# Naval Submarine Medical Research Laboratory

NSMRL/TR--2007-1252

March 28, 2007

## **Results of Inspections of MK-10 Submarine Escape and Immersion Equipment Life Rafts Following Leeway Testing**

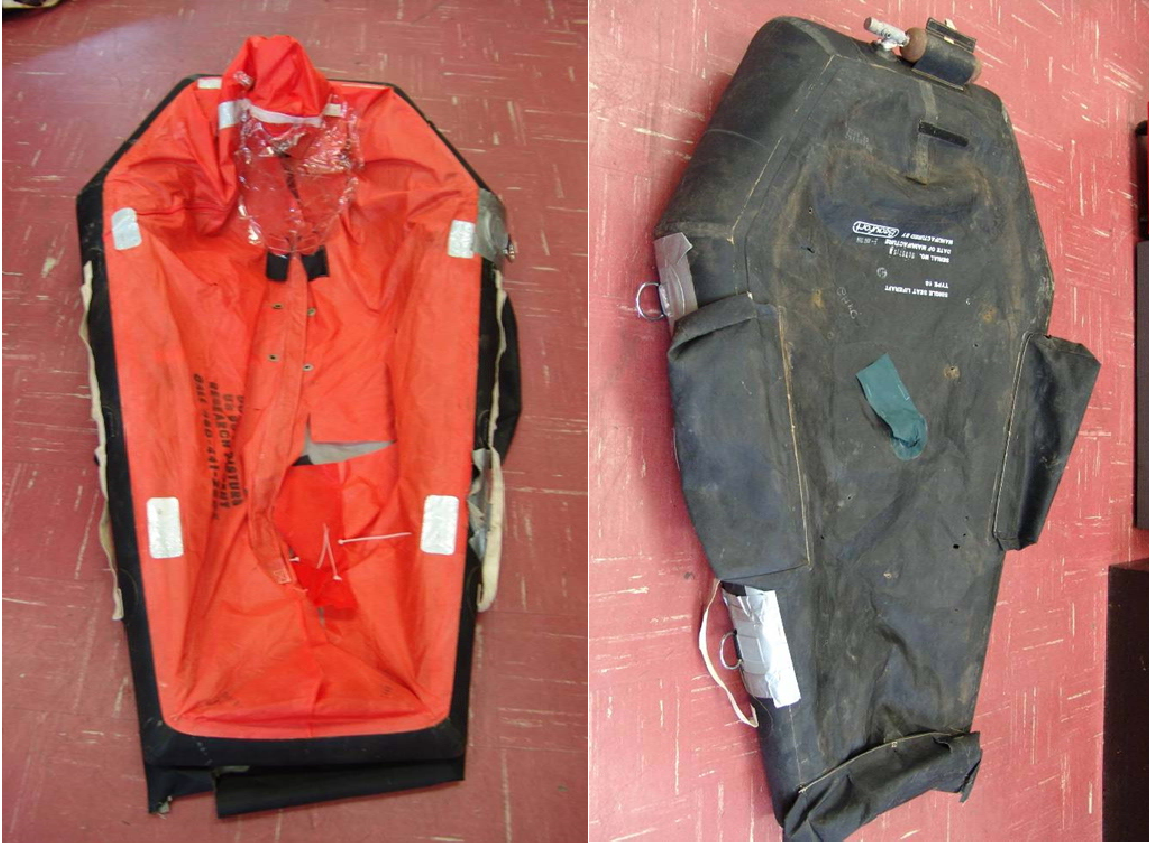
Figure 2: Raft Serial Number 9835715. Top View left, Bottom View right.

- D-rings were added to left side of raft. Grommets were added to the canopy.
- Raft canopy was torn significantly: left side near foot. Plastic face shield torn in center, very jagged tear.
- Electrical tape was placed around the cap on the manual inflation tube to keep it secured in place and possibly to prevent leaking. The manual inflation tube did not exhibit any leaks *without* tape on it.
- No leaks were found on exterior sides of raft.
- The stability pocket at foot of raft had started to tear away from the raft floor at left (as seen from top) end.

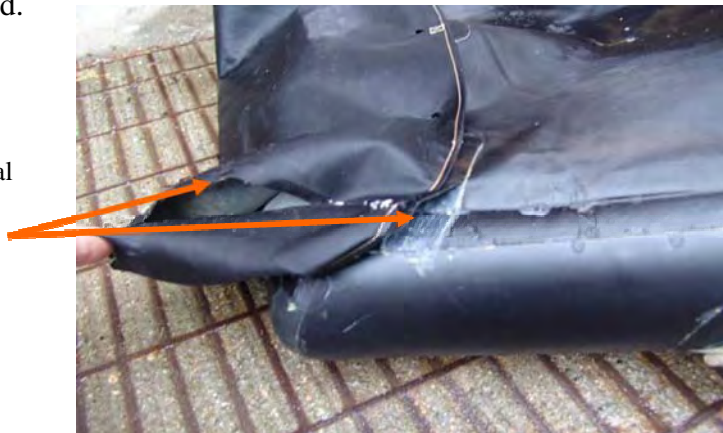
Figure 3: Raft Serial Number 9835715  
Forward Stability Pocket Detail  
(Showing tears)

- Stability pocket at foot end also had an open seam on the left end (as seen from top).
- Two leaks in the buoyancy chamber were located on the inner side of the raft. Both leaks were on right side of the raft in bottom half of buoyancy bladder just above locations where the plywood instrumentation mounting sheet was attached to floor of raft. Both appear to be rub/abrasion locations.

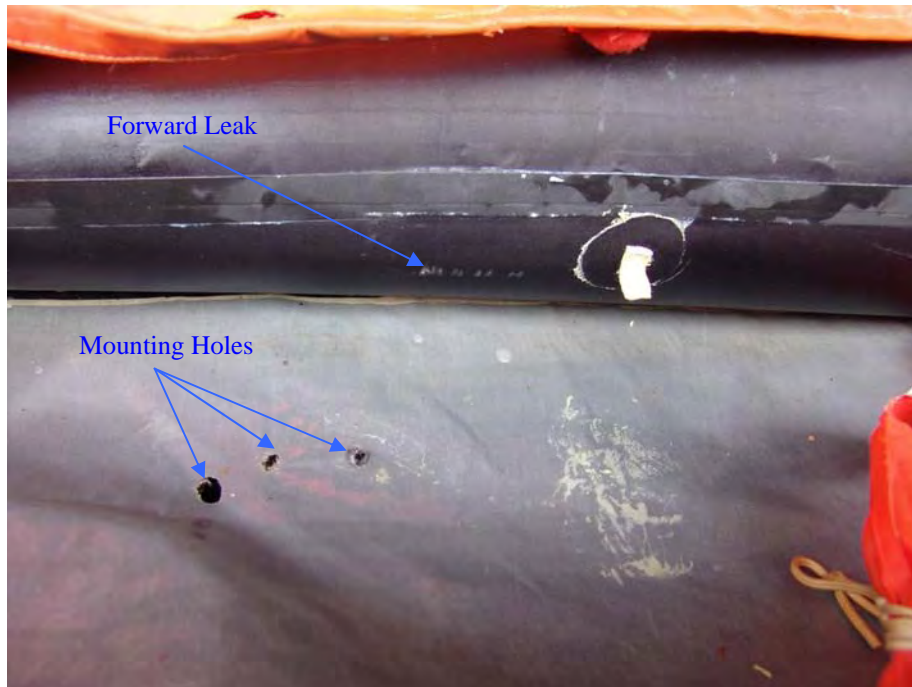
Figure 4: Raft Serial Number 9835715 Detail of Forward Leak

- Raft canopy and face shield were most probably ripped up by the wind during testing.
- The leaks detected appear to have come from abrasions, especially the forward leak. The proximity to the holes in the raft floor where the plywood instrument sheet was mounted seems to imply that the abrasions came from either the plywood sheet itself or the equipment mounted on it.
- The investigators believe that the raft would not have leaked if a human had been the passenger.

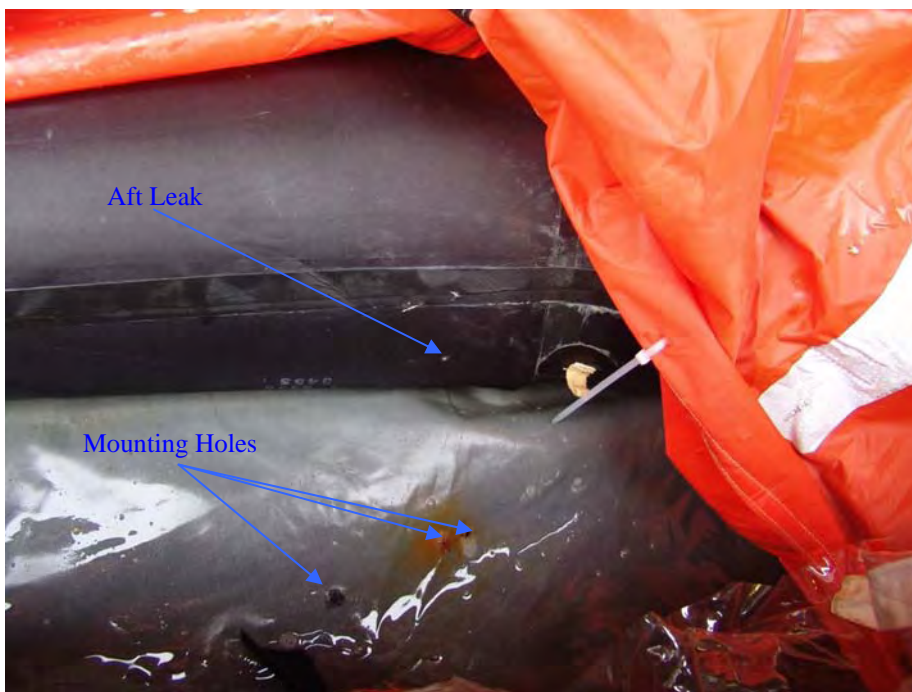
Figure 5: Raft Serial Number 9835715 Detail of Aft Leak

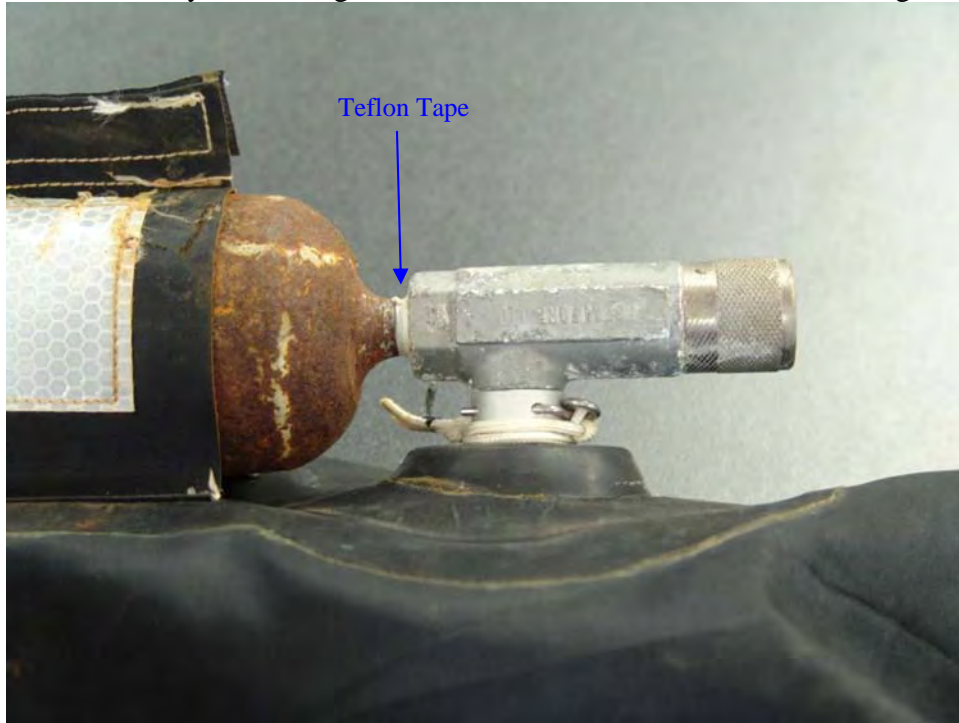
- Raft's CO<sub>2</sub> Bottle had Teflon tape added to the threaded connection to the fill valve assembly. No leakage was observed from that connection during testing.

Figure 6: Raft Serial Number 9835715 Detail of CO<sub>2</sub> Bottle Connection

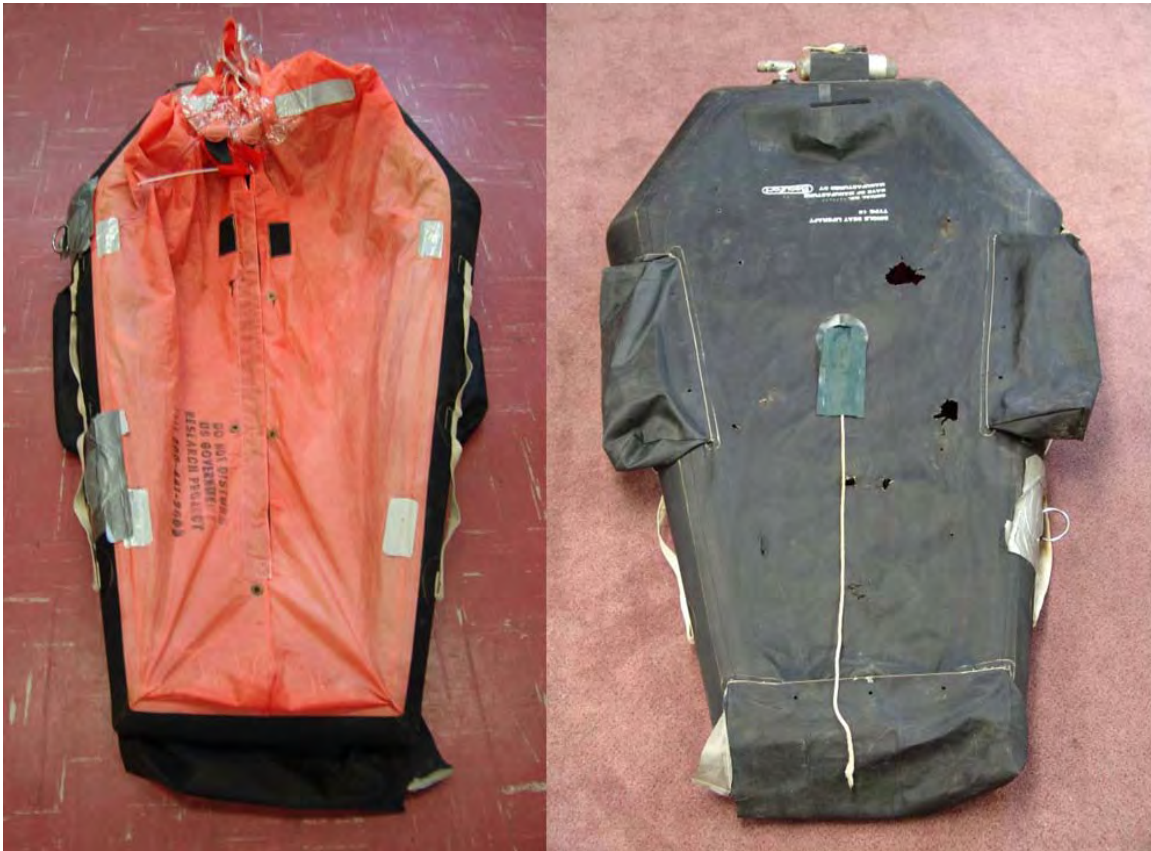
Figure 8: Raft Serial Number 9834882 Top View (Left), Bottom View (Right)

- D-rings were added to the left side of raft. Grommets were added to the canopy.
- Small canopy tears were found around the upper two (aft most) grommets.
- The clear plastic face shield was torn into two pieces. A small part of face shield may be missing. Tear was left/right (horizontal).
- The orange plastic of canopy was significantly sun bleached.
- A significant number of tears and holes were found in the floor of raft associated with points of connection to instrument mounting plate.

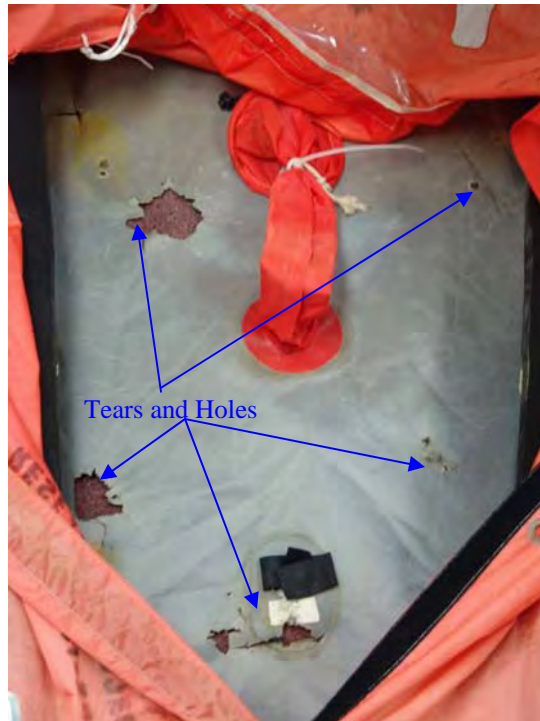
Figure 9: Raft Serial Number 9834882 Interior Views

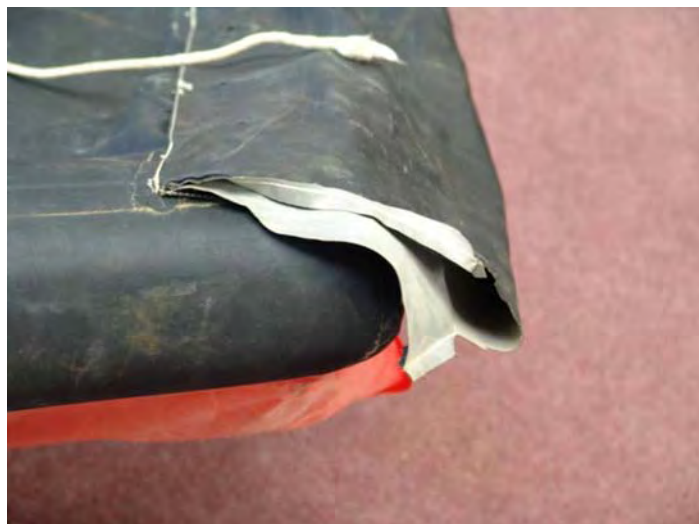
- The forward stability pocket was ripped or cut adjacent to left end seam (as seen from top).

Figure 10: Raft Serial Number 9834882 Forward Stability Pocket Detail

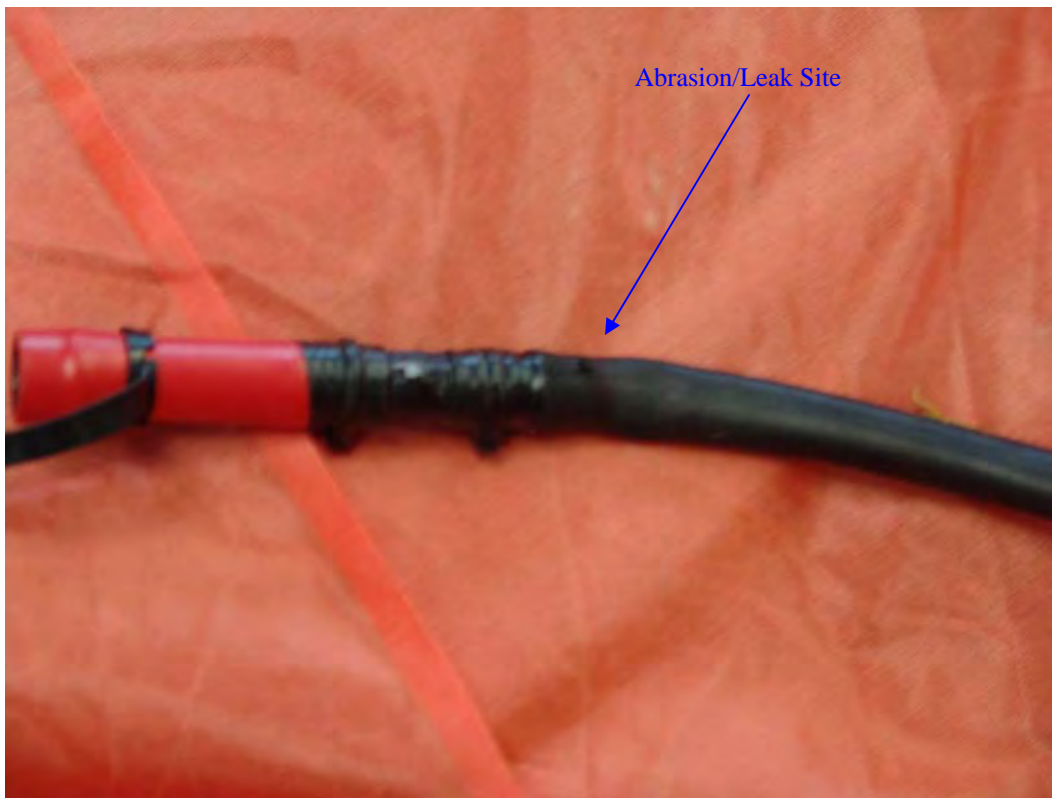
- A significant air leak was found at an abrasion site on the manual inflation tube just below connection to mouth valve. No other leaks found.

Figure 11: Raft Serial Number 9834882 Manual Inflation Tube Detail

- This raft held air longest when inflated. It had a significant amount of air remaining in it after 18 hours. It could easily have been kept afloat by an escaper. Only location of leak that could be found was the manual inflation tube. The abrasion could have come from contact with equipment inside the raft.
- The holes in the floor of this raft were the largest of the group and would have contributed significantly to water entering the raft.
- The investigators believe that the raft would not have leaked if a human had been the passenger.

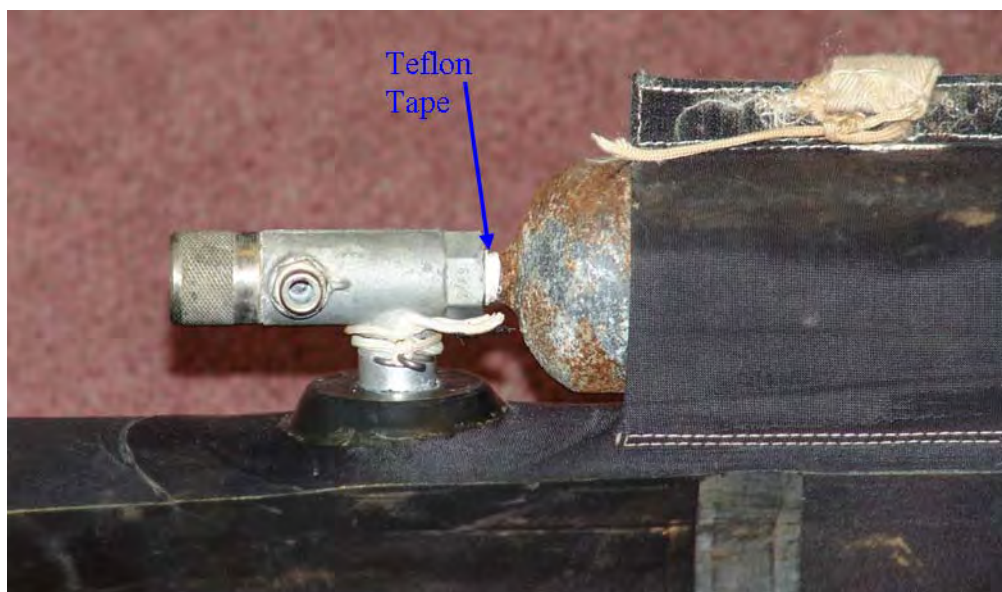
- The CO<sub>2</sub> Bottle had Teflon tape added to the threaded connection to the fill valve assembly. No leakage noted during testing.

Figure 12: Raft Serial Number 9834882 CO<sub>2</sub> Bottle Detail

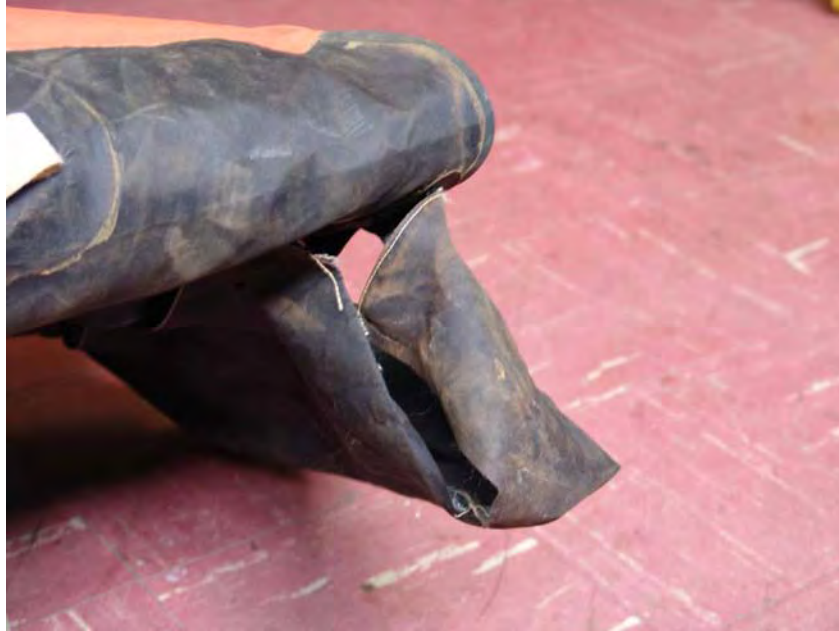
- Two D-rings were added to left side. Eight grommets added to canopy.
- Forward stability pocket was torn along right side seam (As viewed from top).

Figure 15: Raft Serial Number 0364837 Forward Stability Pocket Detail

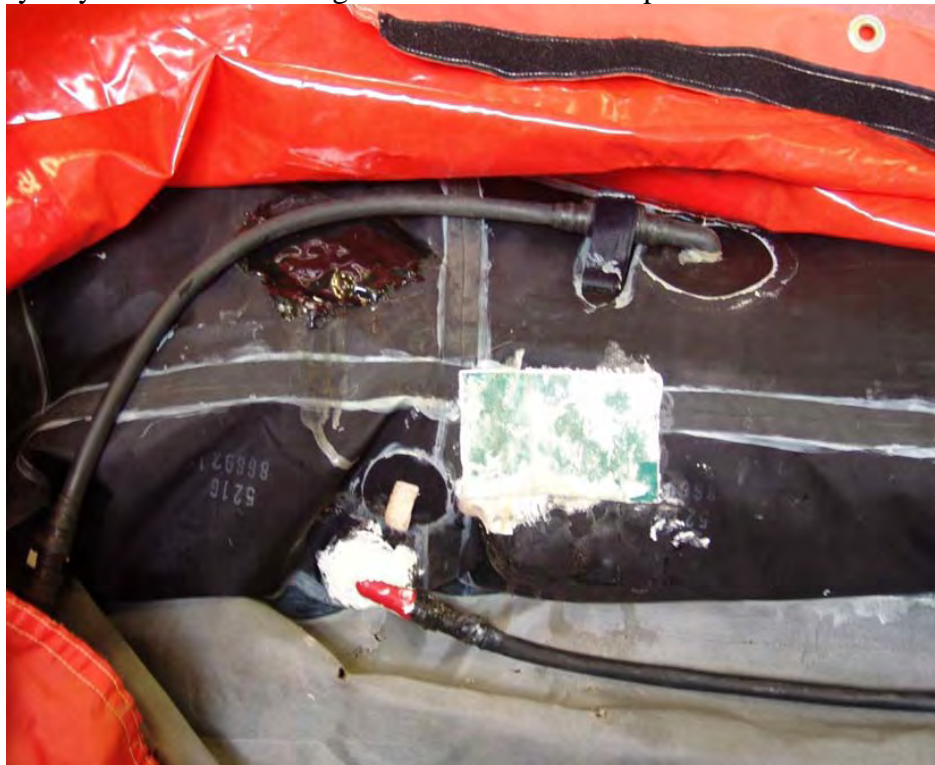
- This was the only raft in the group with two manual inflation tubes. The lower manual inflation tube had white epoxy coated on attachment point to raft buoyancy chamber indicating that a leak had been repaired.

Figure 16: Raft Serial Number 0364837 Manual Inflation Hoses Detail

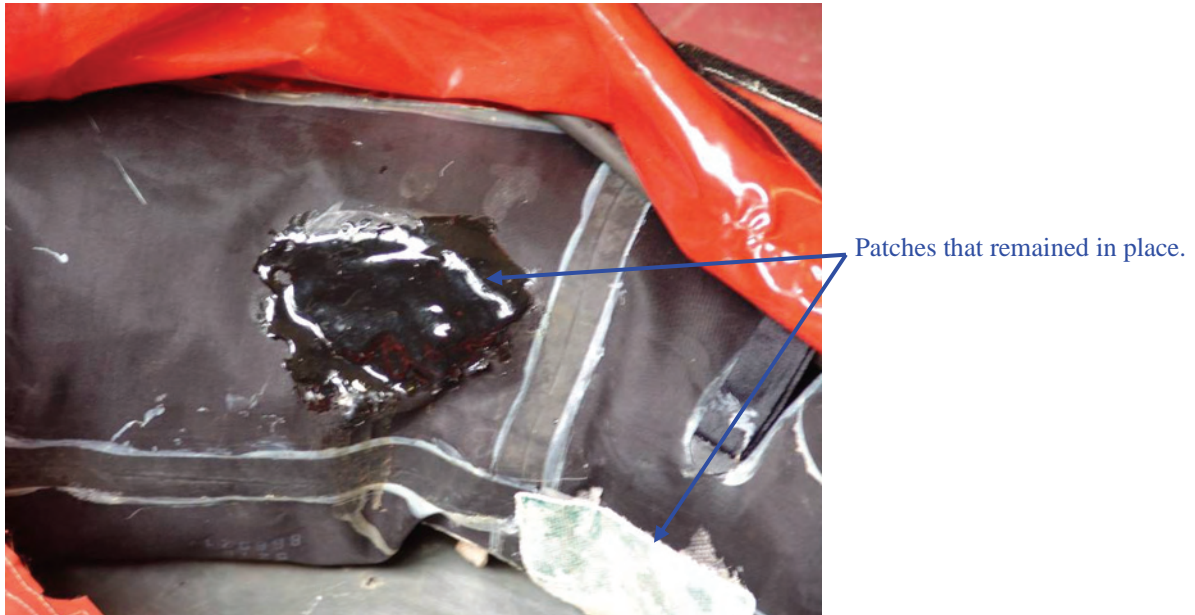
- SAIC added three patches in the vicinity of the two manual inflation tubes. Only two remained in place. None of the leaks occurred at a seam. The leak that was at one time patched was directly below the forward patch (Green colored rubber) and was very significant. The raft completely deflated in less than 5 minutes due to the size of the leak. The patch that seemed most effective was the one made with hard black resin or epoxy.

Figure 17: Raft Serial Number 036483 Installed Patches

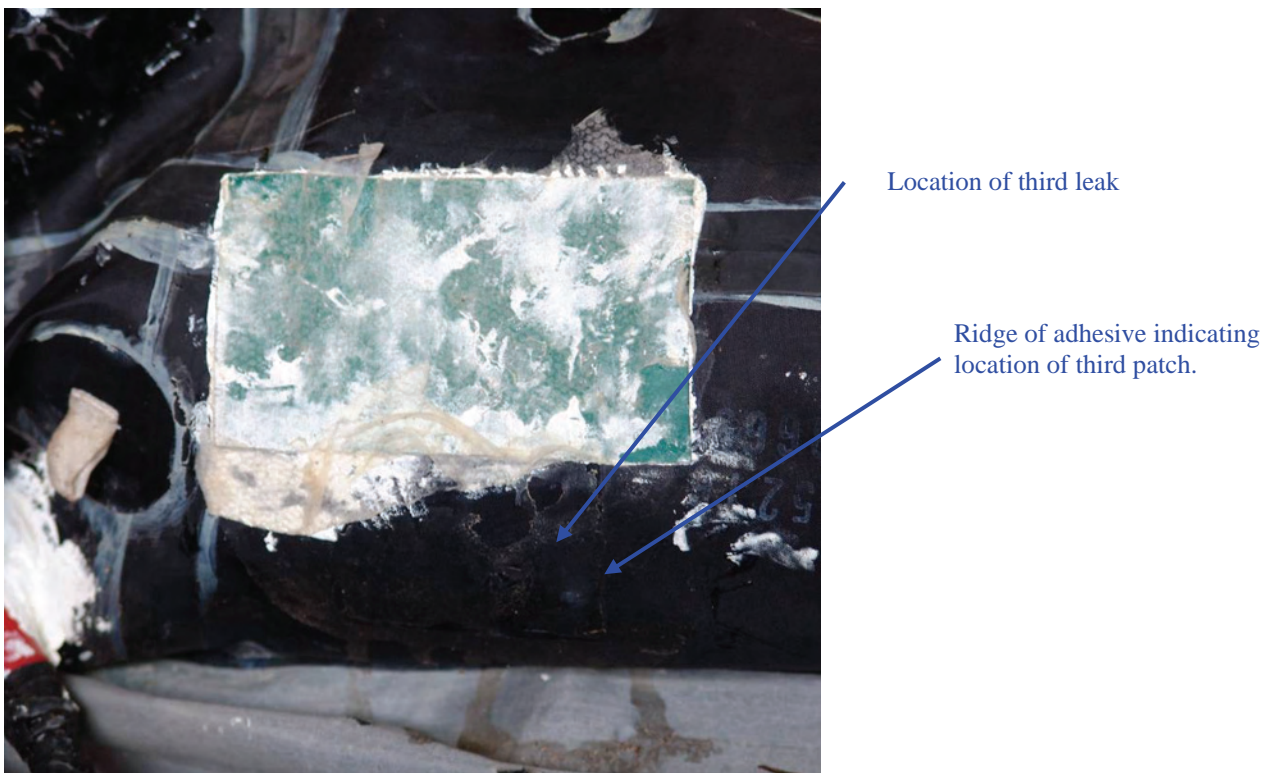
Figure 18: Raft Serial Number 036483 Location of Third Leak

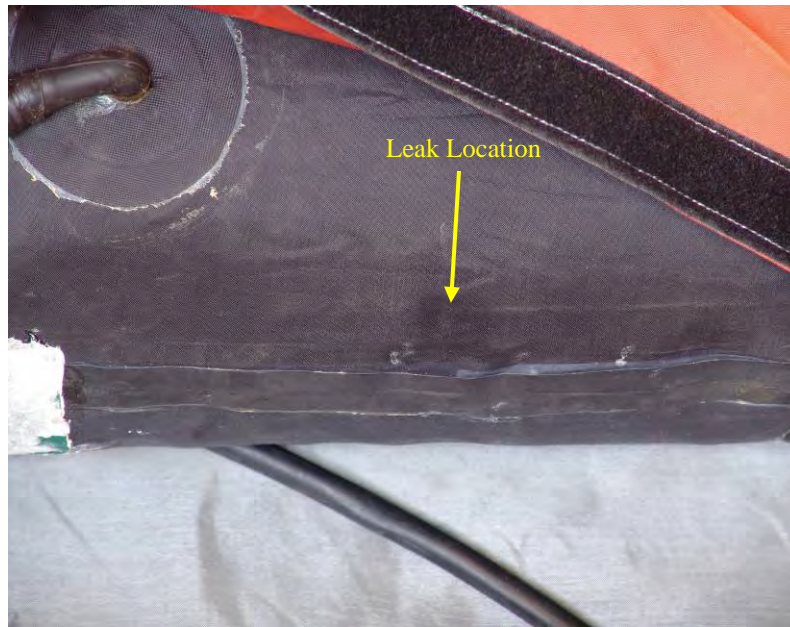
- A fourth pin-hole leak was found about 7 inches forward of the manual inflation tubes on upper half of inflation tube. Slight abrasion of bladder material was noted in the area.
- The CO<sub>2</sub> Bottle had Teflon tape added to the threaded connection to the fill valve assembly. No leakage was noted during testing from the connection.

Figure 19: Raft Serial Number 036483 Location of Fourth Leak

- This raft was clearly in the worst condition with at least four leaks and possibly a fifth leak at the connection of the lower manual inflation tube to the buoyancy chamber of the raft.
- Three leaks were patched; one of the patches failed and fell or was removed from the leak site and was not found. The leak that was “un-patched” appeared to have been caused by an abrasion. The leak was almost 0.5 inches long.
- A fourth small leak developed at a very slight abrasion site forward of the manual inflation tubes. None of the leaks were on seams.
- The investigators believe the leaks were caused by the equipment placed in the raft rubbing against the inside surface of the buoyancy chamber.
- The investigators believe that the raft would not have leaked if a human had been the passenger and if it had been constructed with only one manual inflation tube.

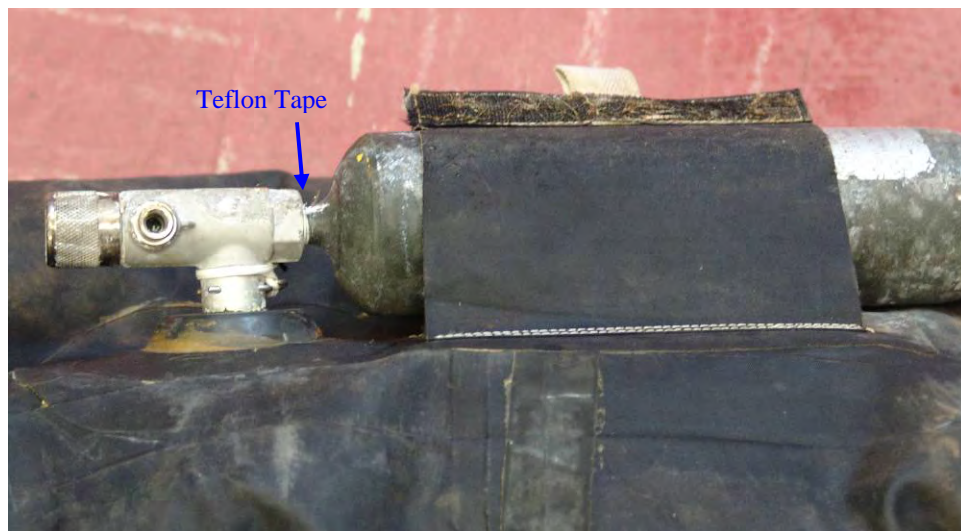
Figure 20: Raft Serial Number 036483 CO<sub>2</sub> Bottle Detail

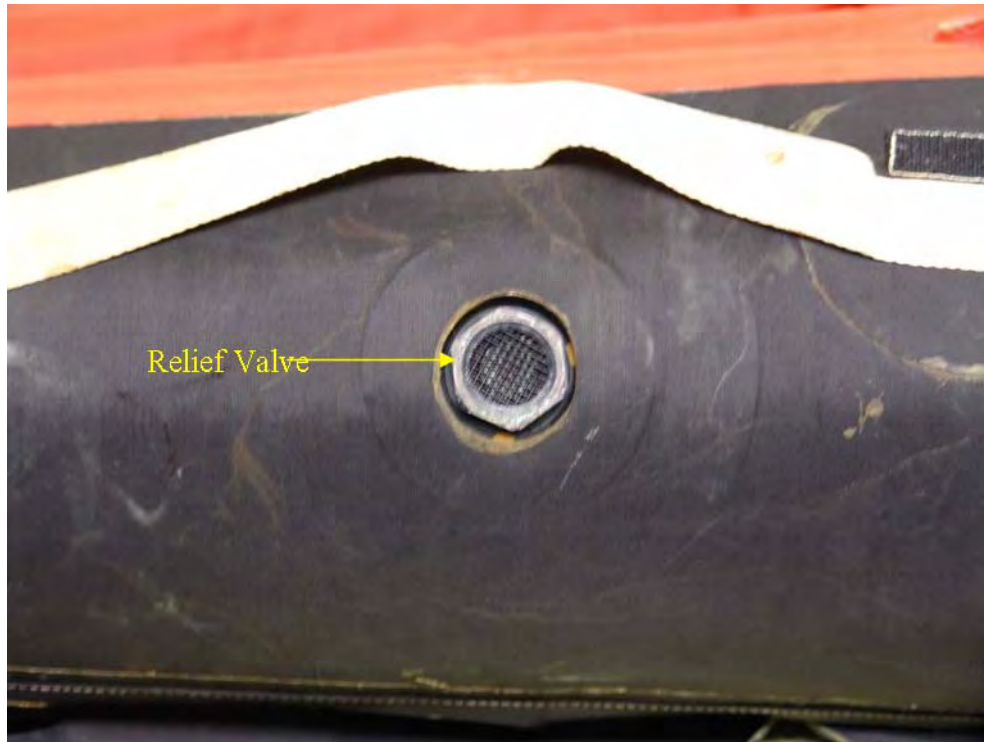
- Two D-rings were added to the left side of the raft. No grommets added to canopy.
- No patches found.
- No leaks in the seams or fabric of the flotation chamber were detected.
- The Over-Inflation Protection relief valve did function (open) as raft reached full inflation and then did not fully reset. Attempts to reseat the valve by directing a stream of water onto the valve were not successful and the valve continued to leak.

Figure 23: Raft Serial Number 0364812 Over-Inflation Protection Relief Valve

- This raft was in the best overall condition of all five rafts with no leaks found in the seams or fabric of the flotation chamber, the smallest mounting holes in the floor of the raft and the least damaged canopy.
- The only leak that could be found was the slow loss of air from the over-inflation protection relief valve failing to reset after opening during inflation.
- This raft held air the second longest of the five tested. The loss could have been kept up with by an escaper using the manual inflation tube.

- The life raft leaks were not a result of poor workmanship by the manufacturer as none occurred at seams.
- The only manufacturing related issues were:
  - Raft Serial Number 0364837 which was constructed with two manual inflation tubes. The lower manual inflation tube apparently leaked at the connection to the buoyancy chamber.
  - Raft Serial Number 0364812 Over-Inflation Protection Relief Valve failure to completely reseal after lifting. The production model MK-10 SEIE life rafts issued to the U.S. Navy Submarine Force does not have an over-inflation protection relief valve thus eliminating that possible leak source.

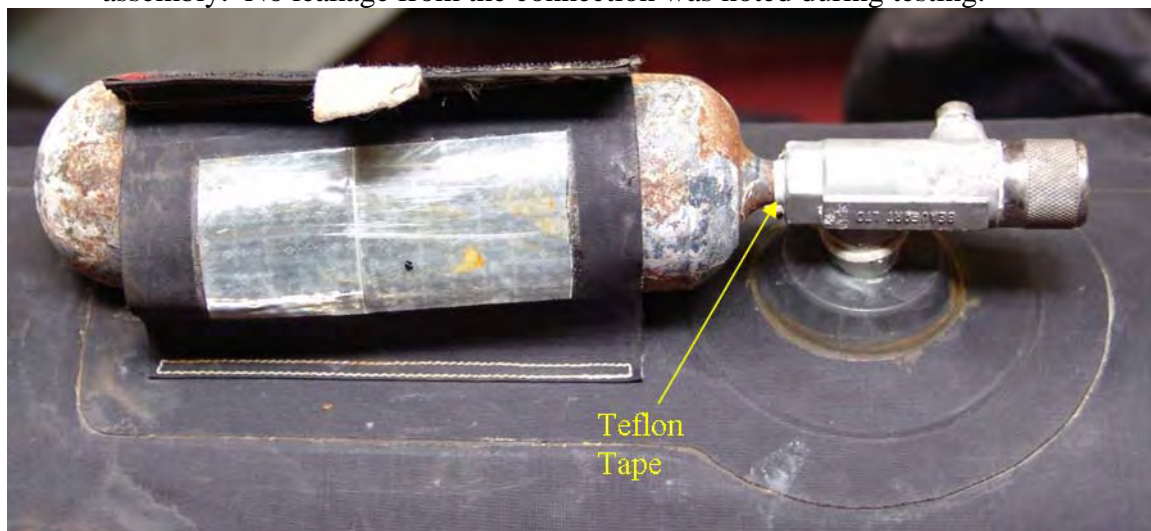
- The CO<sub>2</sub> Bottle had Teflon tape added to threaded connection to the fill valve assembly. No leakage from the connection was noted during testing.

Figure 24: Raft Serial Number 0364812 CO<sub>2</sub> Bottle Detail

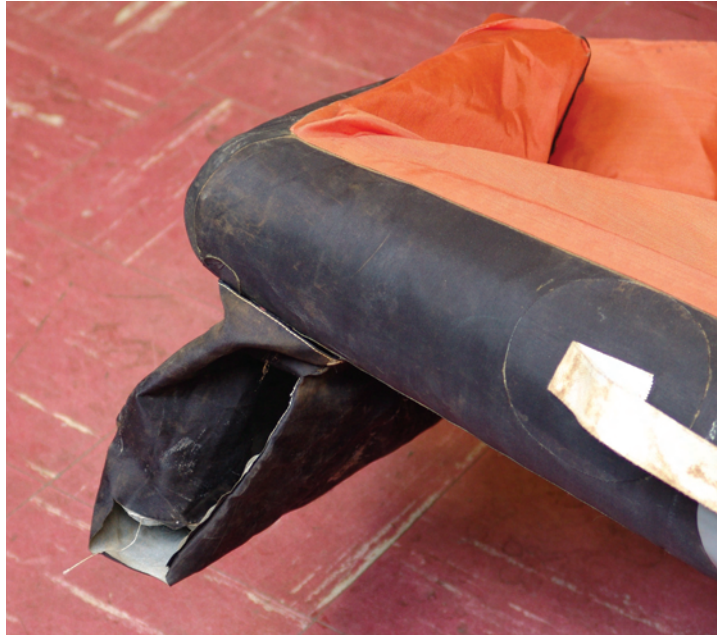
- Two D-rings were added on left side. No grommets added to canopy.
- Forward Stability pocket left side seam (As seen from top.) was ripped open for entire length.

Figure 27: Raft Serial Number 2204171 Forward Stability Pocket Detail

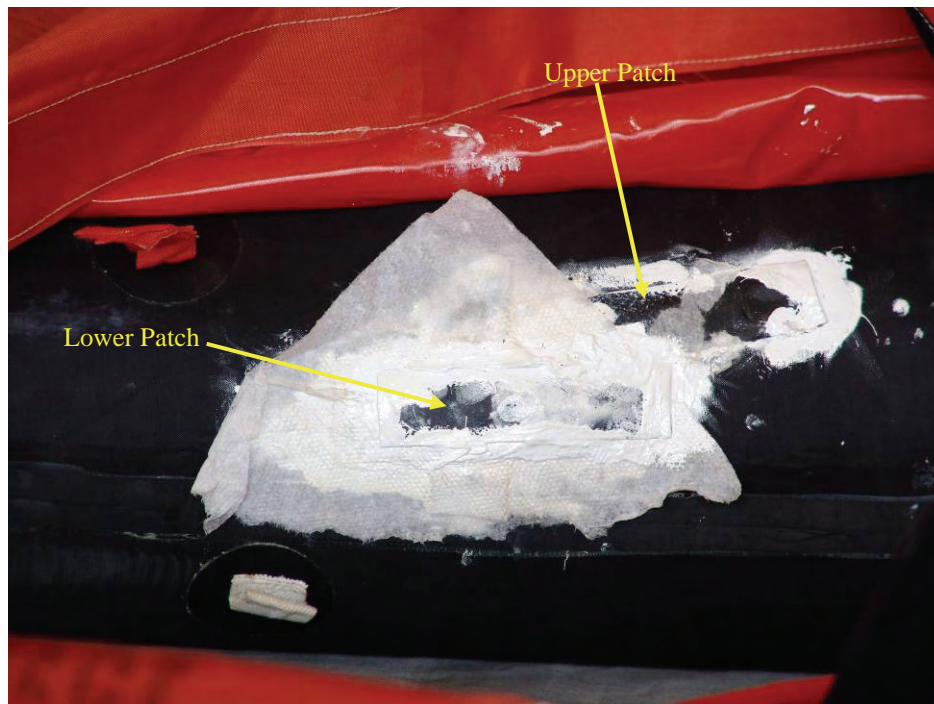
- Two patches were added by SAIC on interior right side. The lower patch leaked significantly.

Figure 28: Raft Serial Number 2204171 Patches Detail

- Raft was in good condition other than the patched leak. If the lower patch had not failed the raft would have held air. The patched leak was roughly in the same position fore and aft as the pin-hole leak found on raft serial number 0364837 (Raft with two manual inflation tubes.) and not on or very near a seam.

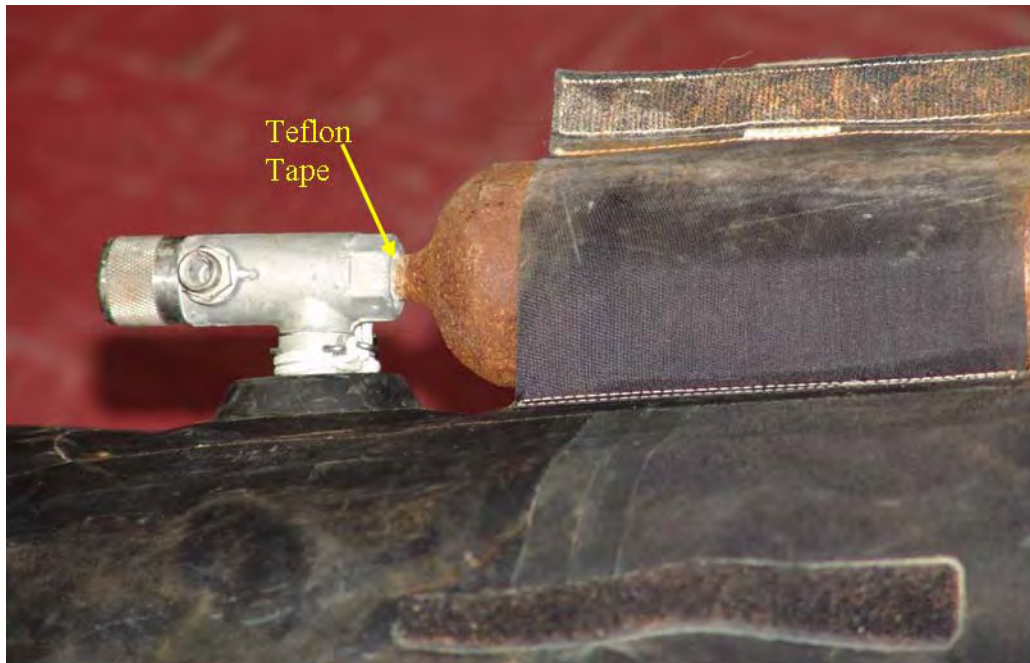
- No other leaks found.
- The CO<sub>2</sub> Bottle had Teflon tape added to the threaded connection to the fill valve assembly. No leakage was noted from the connection during testing.

Figure 29: Raft Serial Number 220417 CO<sub>2</sub> Bottle Detail
